Name Of Dam: STAUNTON DAM
Location: AUGUSTA COUNTY, VIRGINIA
Inventory Number: VA. NO. 01518

PHASE I INSPECTION REPORT

NATIONAL DAM SAFETY PROGRAM

SCHNABEL ENGINEERING ASSOCIATES, P.C./
J. K. TIMMONS AND ASSOCIATES, INC.

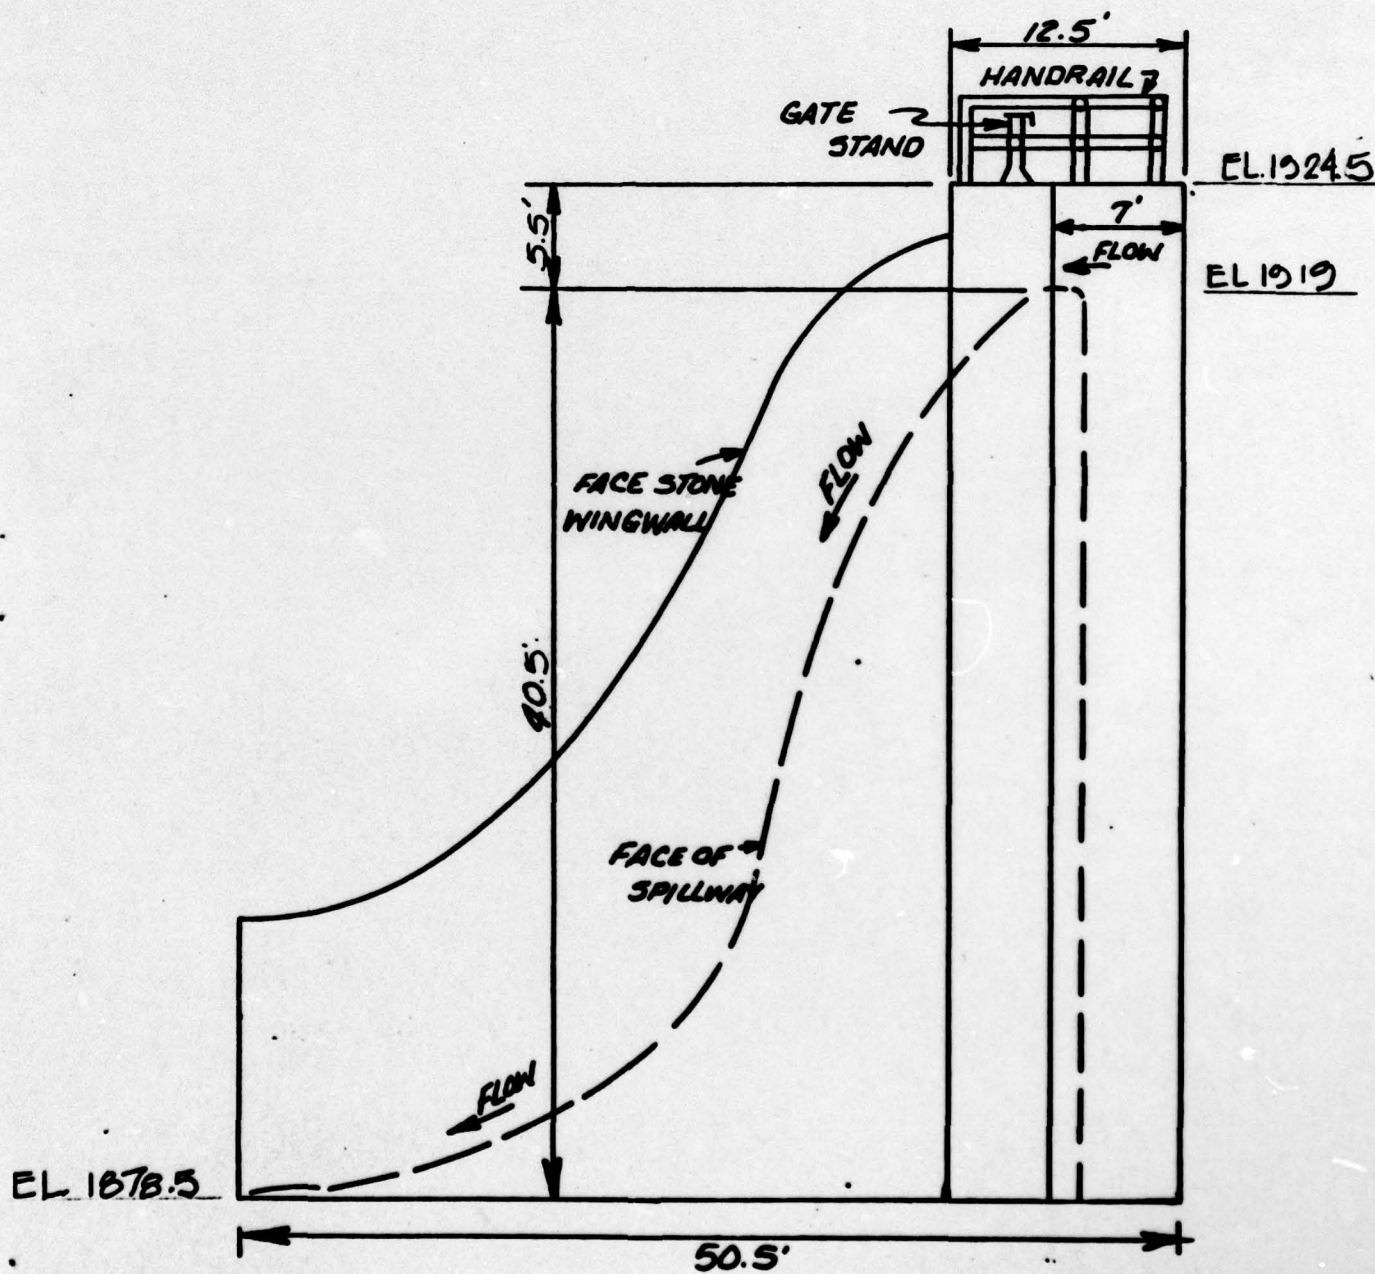
STAUNTON DAM
BASIC SECTION OGEE SPILLWAY
 NO SCALE

The visual inspection of the dam revealed no apparent problems. However, a check of the stability in accordance with Corps of Engineers' guidelines, assuming the dam is founded on the surface of the rock, indicates the structure does not meet the requirements of Reference 1, Appendix V. An accurate check on stability could not be made since design data and calculations were not available. Thus, we recommend that the owner have a study performed to evaluate in detail the actual stability condition of the dam.
